**Subject: Geotechnical Engineering Services - Preliminary Assessment of a landslide, located in the slopes of properties 739 and 751 Ash Street, Campbell River, BC**

**PROJECT**  
Preliminary Geotechnical Assessment of a landslide, located at 739 and 751 Ash Street, Campbell River, BC

# Photograph report

**Project:**  
Geotechnical Assessment of a Landslide

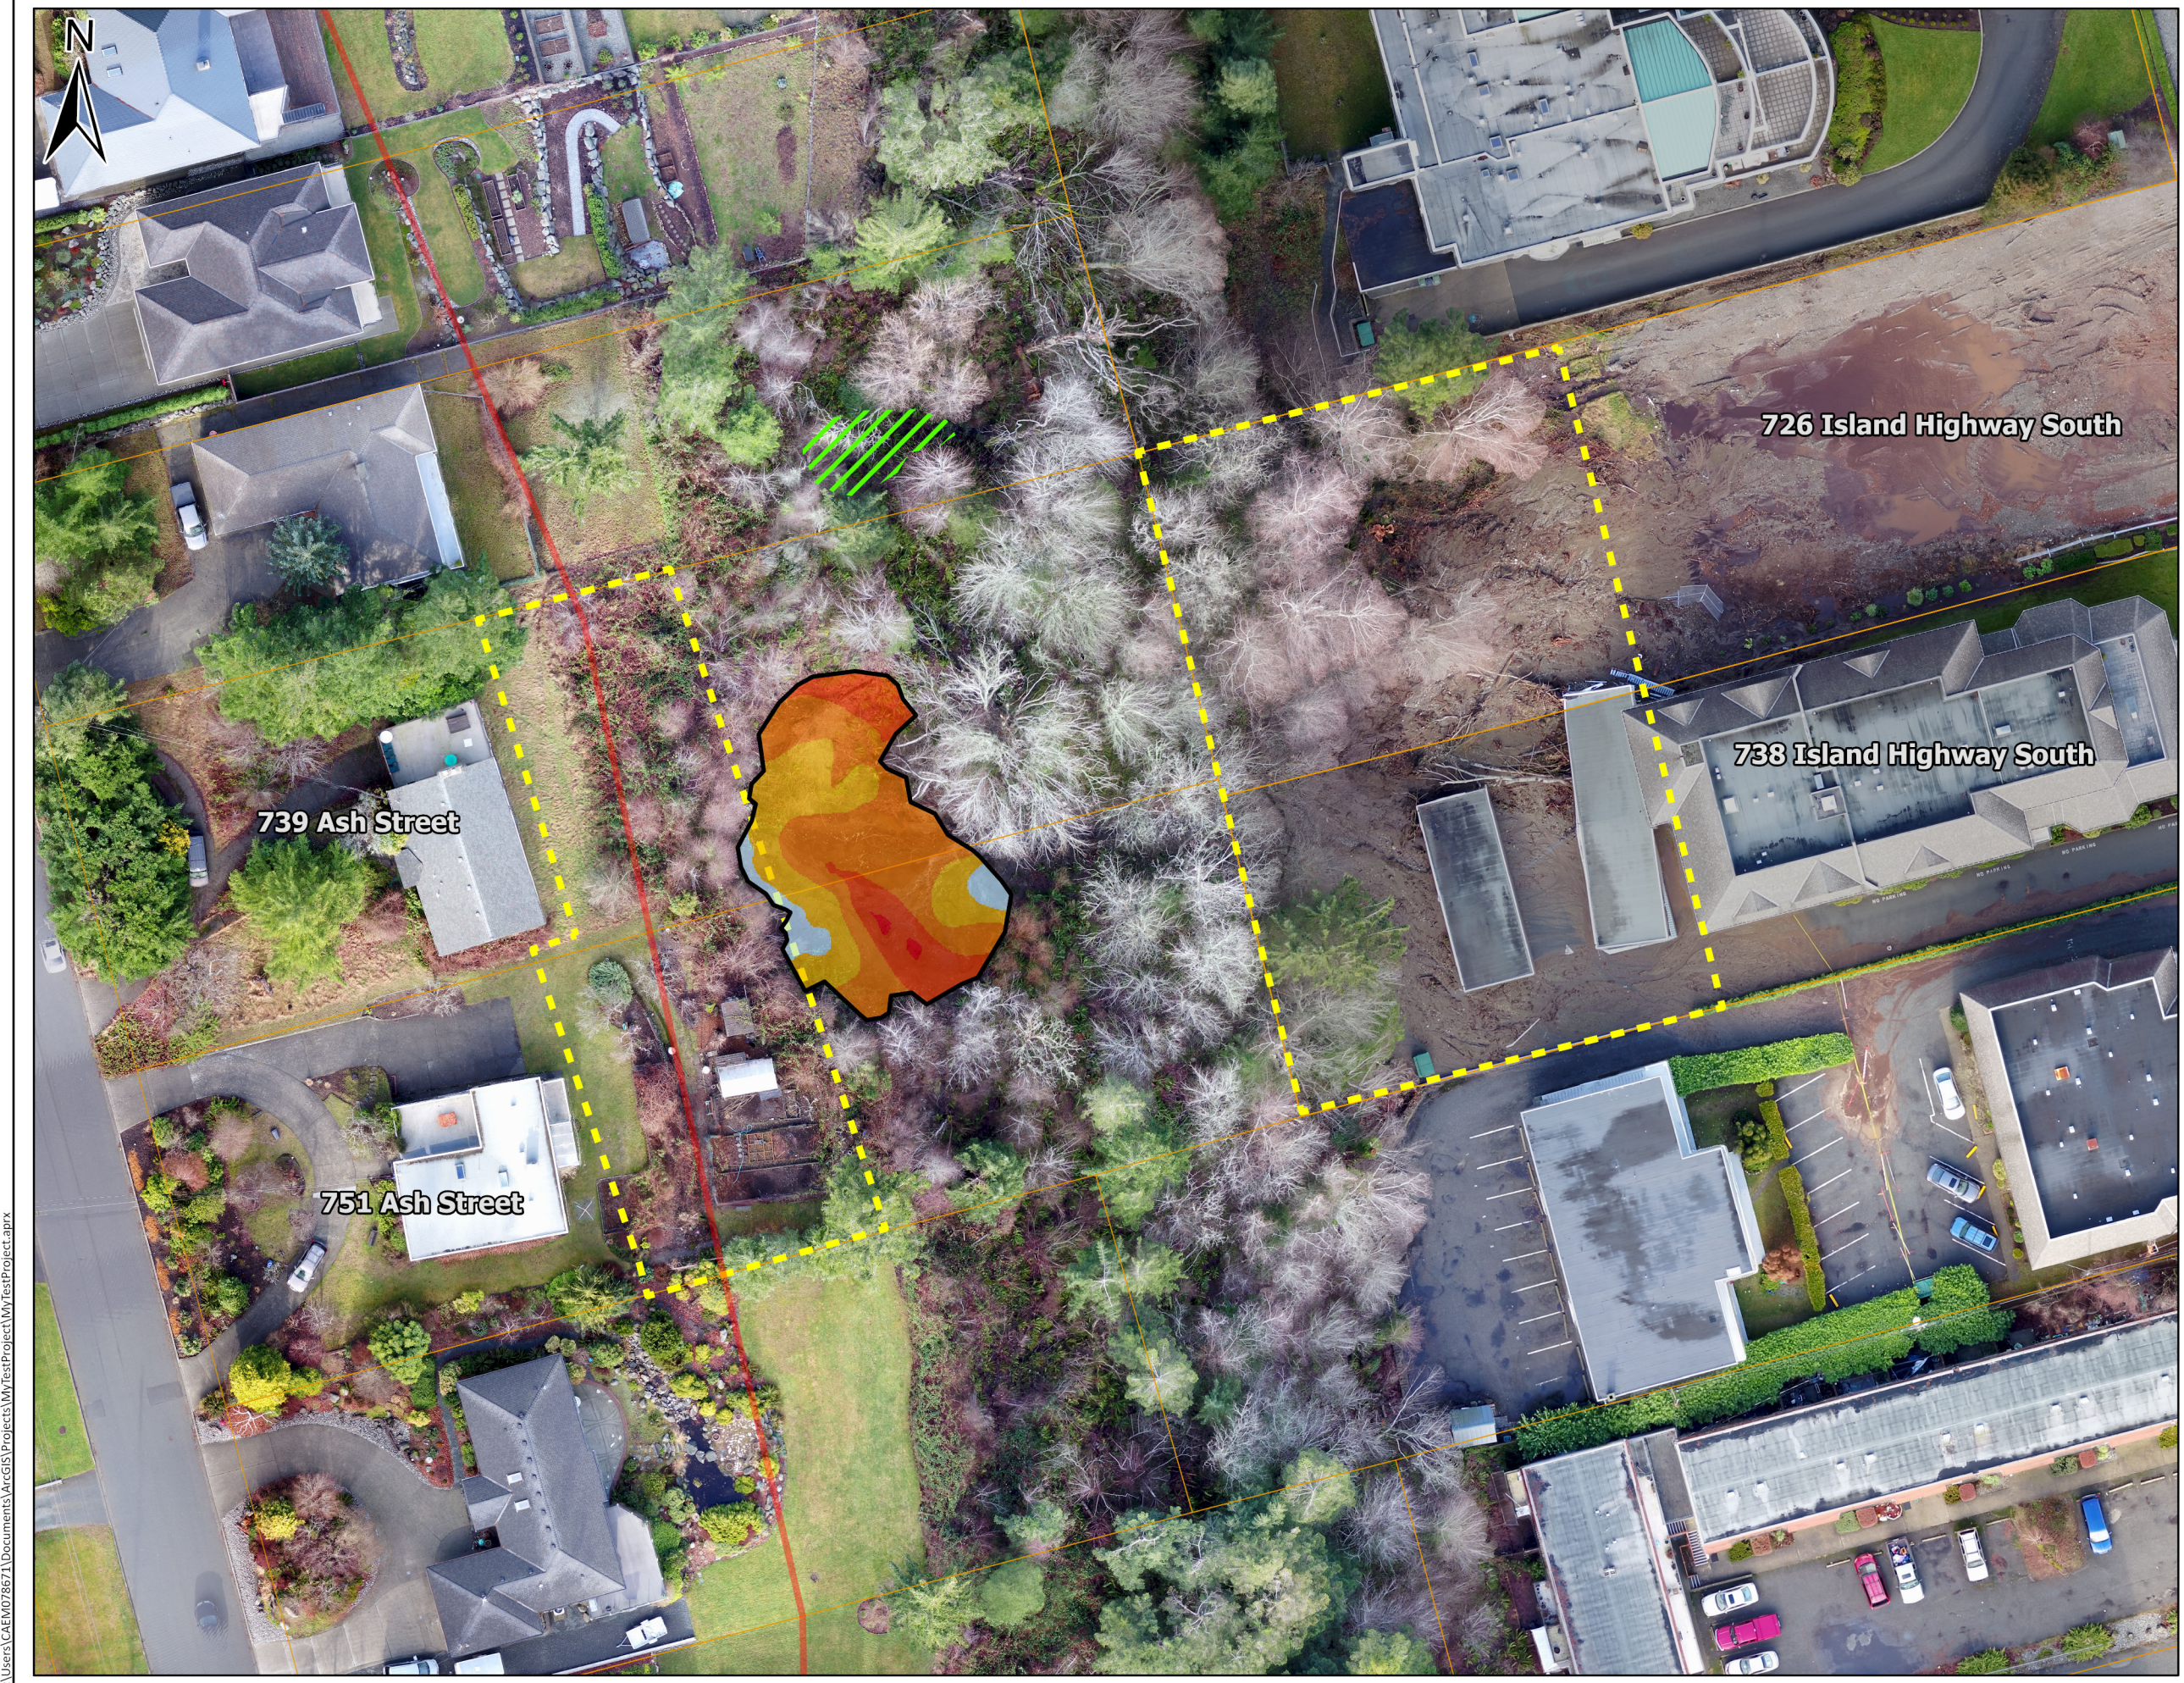
**TITLE**  
Landslide scar and recommended restricted area

- The landslide occurred in the upper half of the approximately 40 m high slope, creating a circular shaped scar that measured approximately 30 m laterally and about 15 m long parallel to the slope (main scarp). The depth of the slide was estimated from pre and post contours to range from zero to over 3.5 m as shown on Figure 1. Geologically, the upper part of the Main Scarp (2-3 m) consisted of very dense glacial till that was underlain by 15-20 m of dense sandy deposits laying on dense fine-grained material. In the Main Scarp, the upper 2-3 m of glacial till were almost vertical with some localized overhanging surficial soils. The underlying dense sandy deposits were interpreted as Quadra sands, which were exposed at an angle of approximately 40-45 degrees (see Photos 9 and 10). The underlying finer grained deposits were interpreted to be Quadra sediments and observations indicated that the bulk of the landslide had not affected their integrity. The failed slope material appears to have behaved like a fluid mass as it flowed into position. The surface of rupture seems to be located at the interface of the Quadra Sands and the underlying fine-grained sediments;

Following the visit, the City of Campbell River provided WSP with some drone imagery and LiDAR data, taken following the landslide. The drone data provided some survey points which allowed post landslide contour lines to be defined at the location of the landslide. The adjacent tree covered ground could not be interpreted accurately with the drone data and the depth of possible debris within the landslide scar are also unknown. By transposing topographic surfaces pre and post landslide, it has been estimated that roughly 550 m<sup>3</sup> of soil have been displaced by the landslide. The landslide scar has been shaped from the data and is presented in the figure attached to this letter.

- Erect a safety perimeter at the top of the slope, as per the figure attached to this letter, restricting human access, on both backyard areas of properties located at 751 and 739 Ash Street pending the completion of short-term remedial works. The City of Campbell River public works crew may enter to address issues related to the sanitary sewer, but we would recommend that this be completed in conjunction with further geotechnical review.
- Establish a surveillance program to review the condition of the slope, seepage rates and monitor any change in conditions particular to the upslope. Select removal of the blackberries is recommended to allow a review of the crown area. We would recommend an initial regular two-week interval plus after prolonged periods of heavy rain.

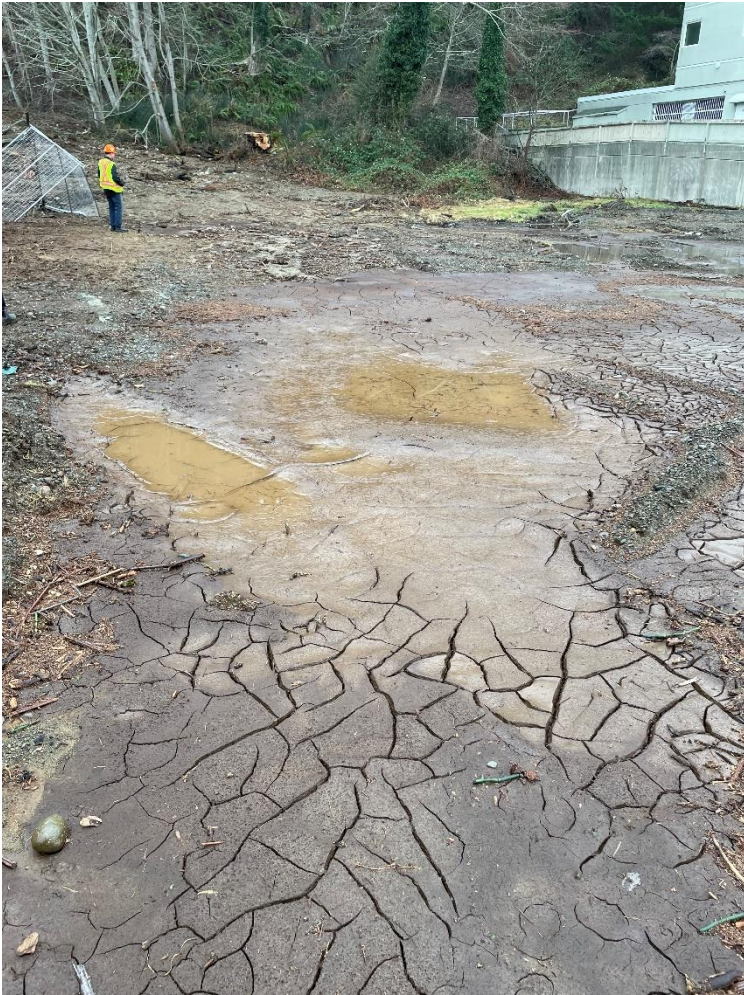
- Some trees were uprooted and damaged in the landslide, but most surrounding trees are mature and still stand on either side of the landslide;
- The debris at the toe of the landslide consisted mainly of sandy soils closest to the slope, and of finer grained soils (silt/clay) at the outer edge of the failed mass. The thickness of the debris deposited adjacent to the apartment building was approximately 0.15 m deep at the outer fringe, and up to 0.6 m near the original toe of the slope. The nature of the failed debris is shown in Photos 1, 3 and 7;

Photo 1 : 738 South Island Hwy, mudslide deposit at toe of failed slope.

- Clean-up the debris at the bottom of the slope only (beyond the toe of the slope). Clean-up should only be completed in dry conditions or very light rain and should not follow any significant precipitation event within 24 hours after the occurrence. A geotechnical presence is recommended during the clean-up to observe potentially new findings and provide a periodic assessment of the condition of the slope;
- Residents evacuated from the lower buildings may be allowed to return, subject to positive findings from the structural engineering assessment. We would also recommend that at least temporary measures be completed to collect and safely convey the seepage prior to a full return of residents.

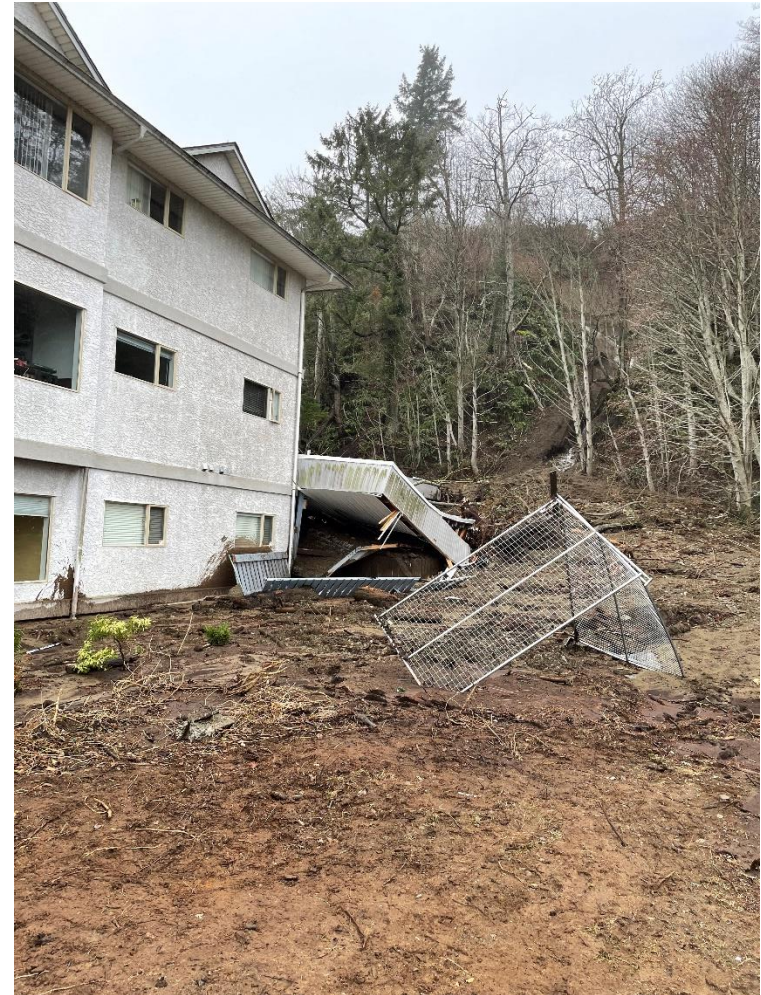
- Significant damage on some parking shelter structures was incurred at the toe of the slide, located mostly at 738 Island Hwy South. The two standing structures were completely damaged with one of the structures leaning on the condominium building, potentially affecting the building's structural integrity (see Photos 2 and 3);

Photo 2: 738 South Island Hwy, damaged structure at toe of failed slope and soil debris from the landslide.

- Obtain a structural engineering assessment of potential structural damage to the rear of the buildings and out structures impacted by the landslide;
- Obtain civil engineering services related to the collection and off-site conveyance of the concentrated seepage at the toe of the slope. This will need to include a component of erosion and sedimentation control due to the proximity of aquatic discharge. This work

The parking structures at the rear of the building were impacted significantly and it is not clear if the structures can be salvaged or will need to be replaced. It is noted that the parking structures absorbed a substantial amount of energy from the mudslide that could otherwise have caused more serious damage to the rear of the building. The rear area currently used for parking has the greatest risk of impact from future landslides and we would recommend that it not be used until a risk mitigation plan has been developed (see below). Limited parking appears to be available at the front of the building and at the nearby Rotary Beach Park. ;

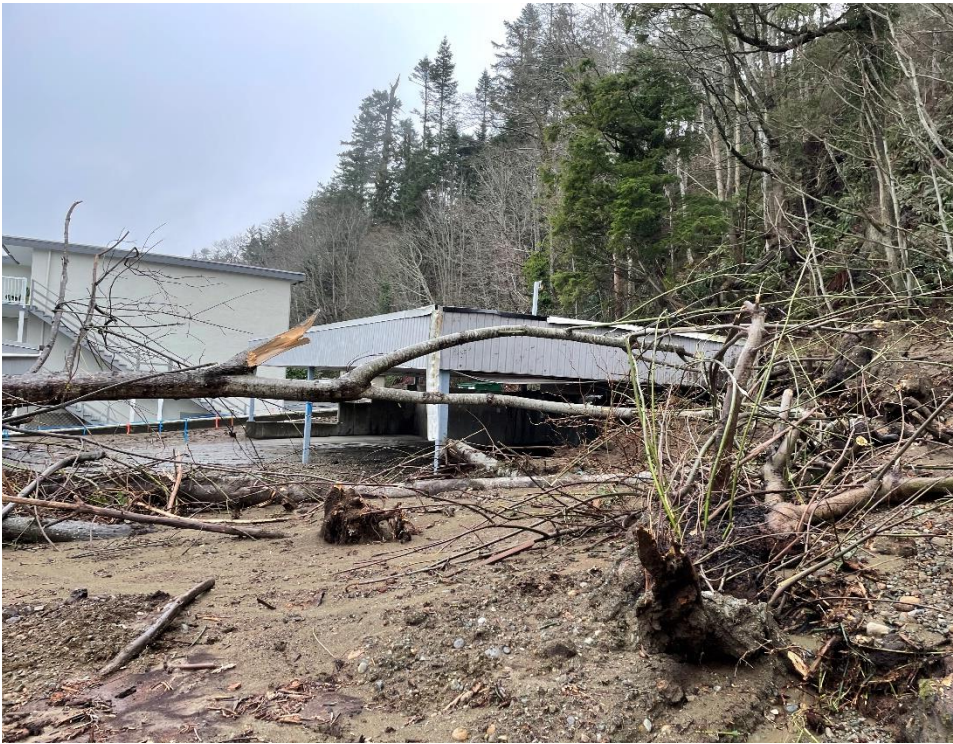
Photo 3 : 738 South Island Hwy, damaged structure and torn out trees at toe of failed slope.

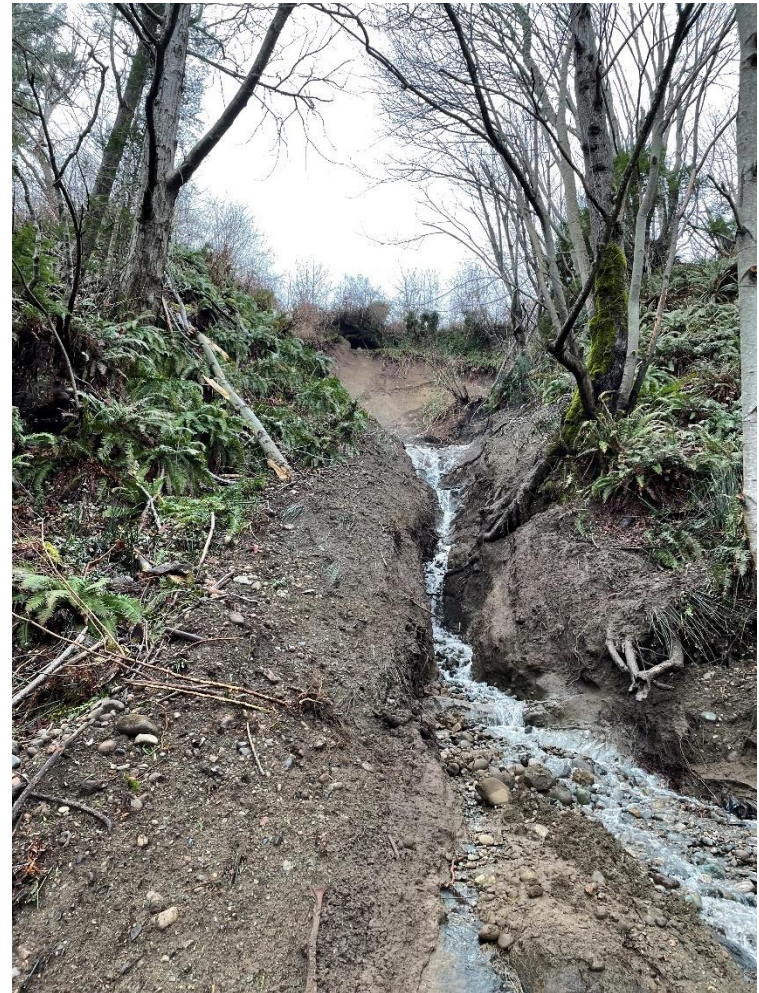
- Drainage collection and conveyance measures had been constructed prior to the landslide and are indicative for historic drainage at this location. At the bottom of the slope, the measures included a concrete slab and a 100 mm dia. PVC pipe that was broken as a result of the slide;

Photo 4 : Toe of slope, heavy water flow continuing two days after the slide event.

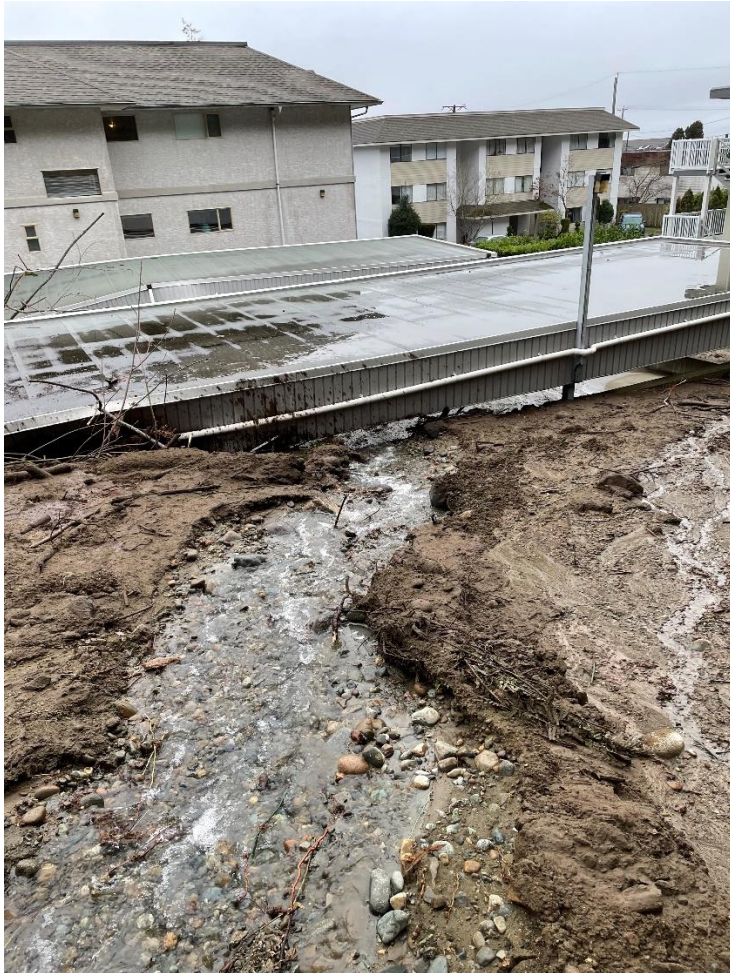
- Following the rupture and damage to the drainage works, the water was observed to flow uncontrolled on the paved area to open ditching on the Island Hwy ditch (see Photos 5 and 6);

Photo 5 : Water flow towards 738 South Island Hwy Building.

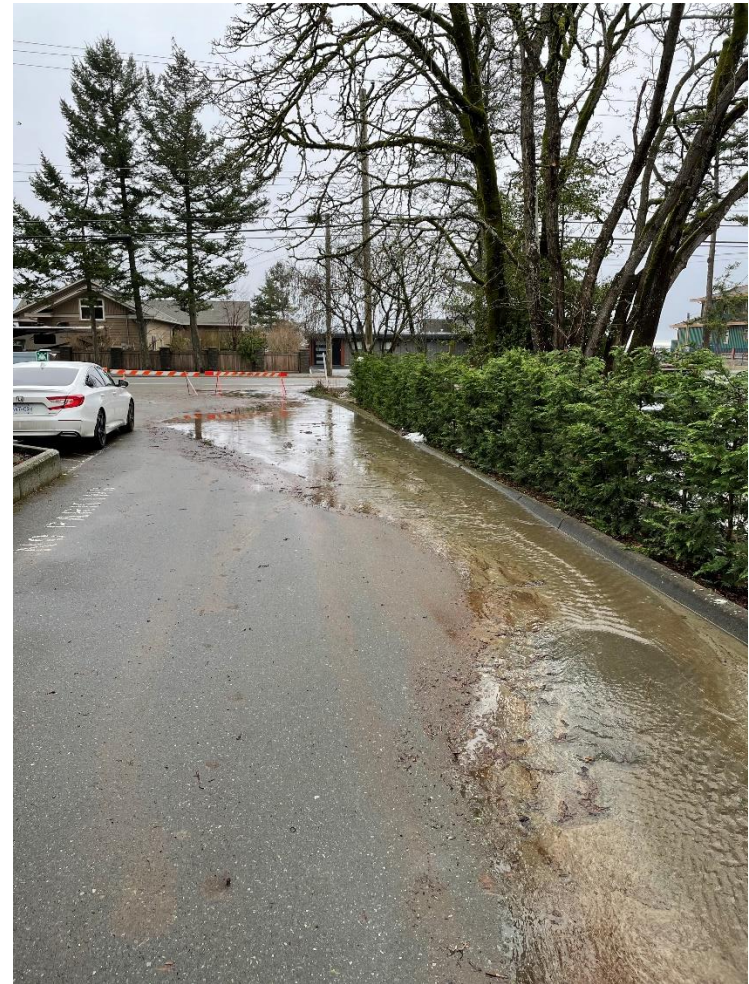
Photo 6 : Water flow towards South Island Hwy ditch.

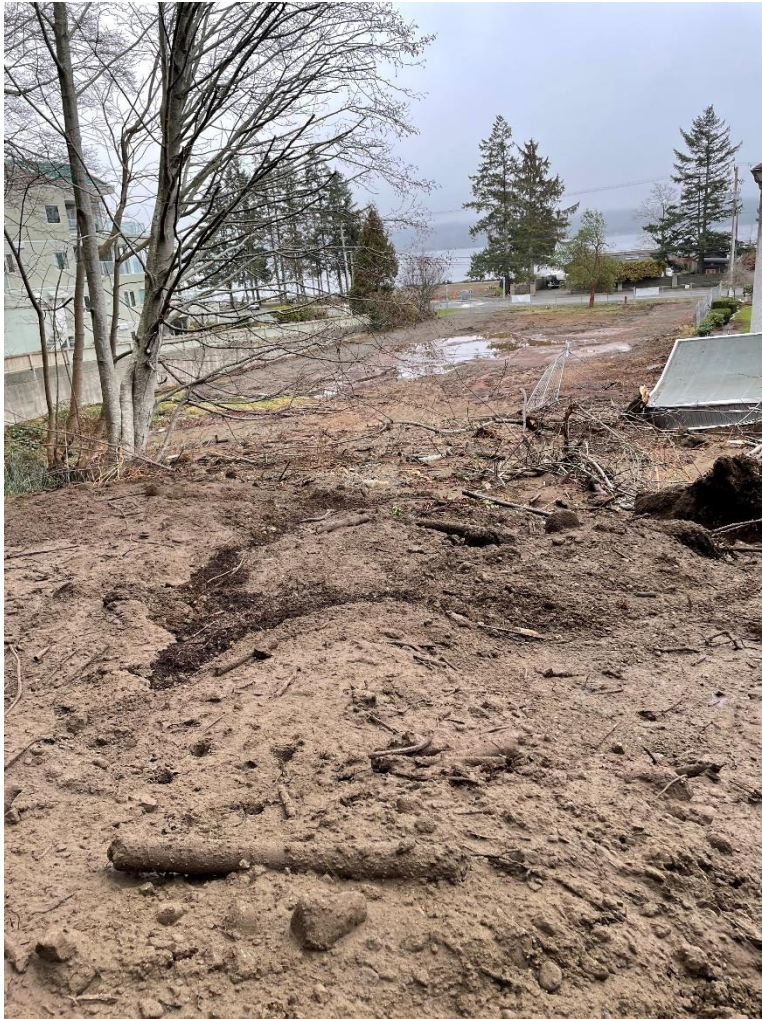
Photo 7: Debris at toe of failed slope.

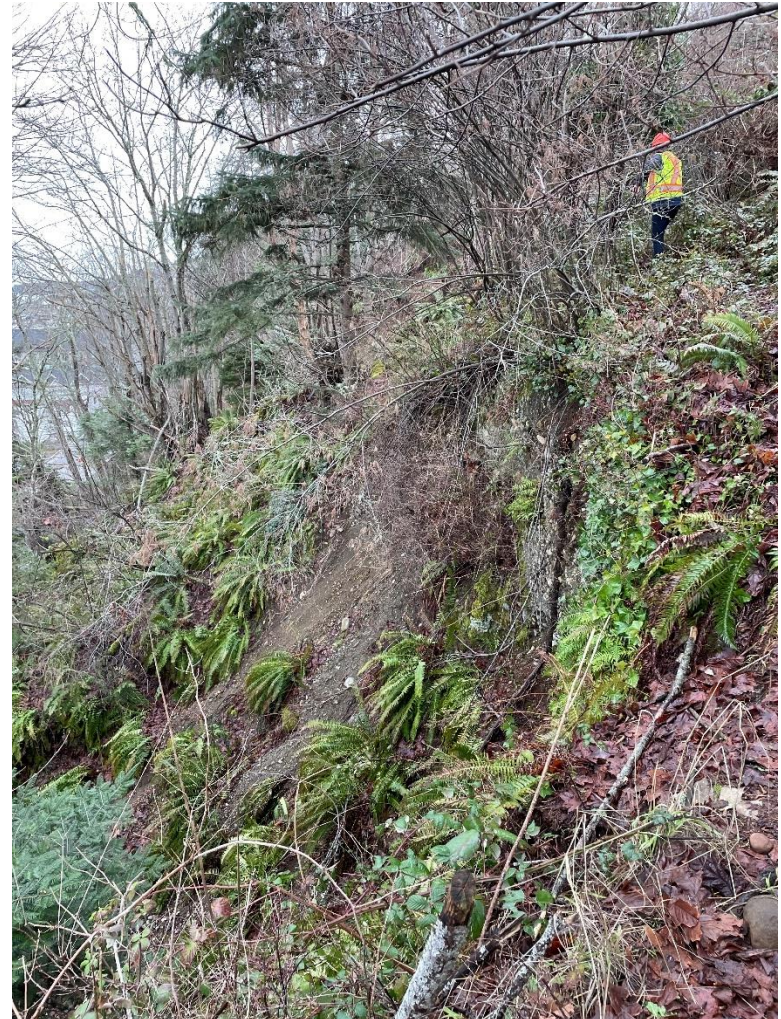
- To the north of the landslide, on the same slope, a small-scale erosion/ failure, was observed at the property located at 723 Ash Street. The feature corresponds with the rounded contour lines observed at this location. No seepage was observed at this location (see Photo 8);

Photo 8: Shallow slope failure in the slope on property 723 Ash Street, north of the assessed failed slope.

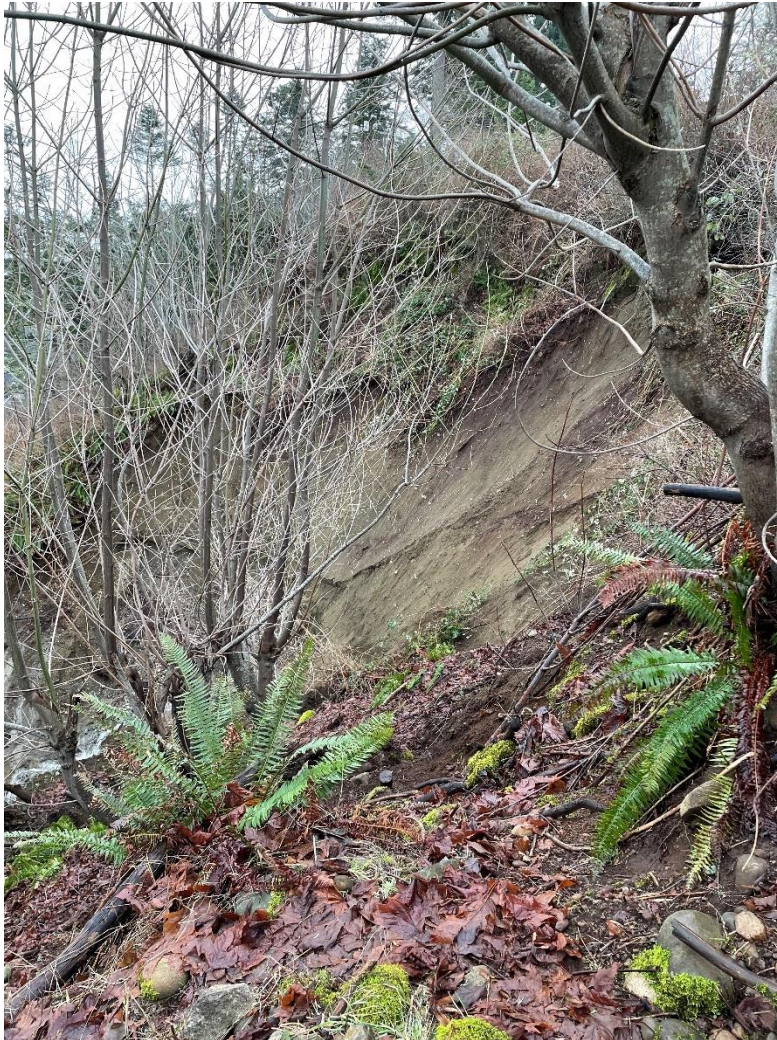
Photo 9 : View of the head scarp from the north.

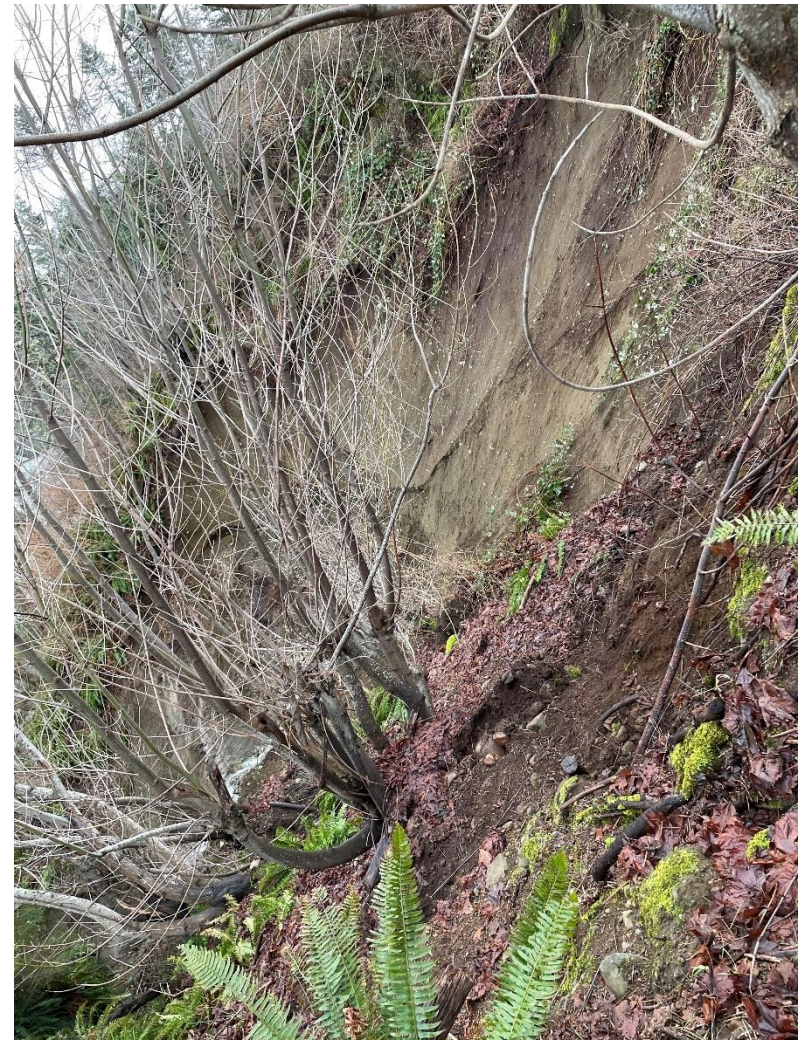
Photo 10 : Visible quadra sands in the scarp of the failure.

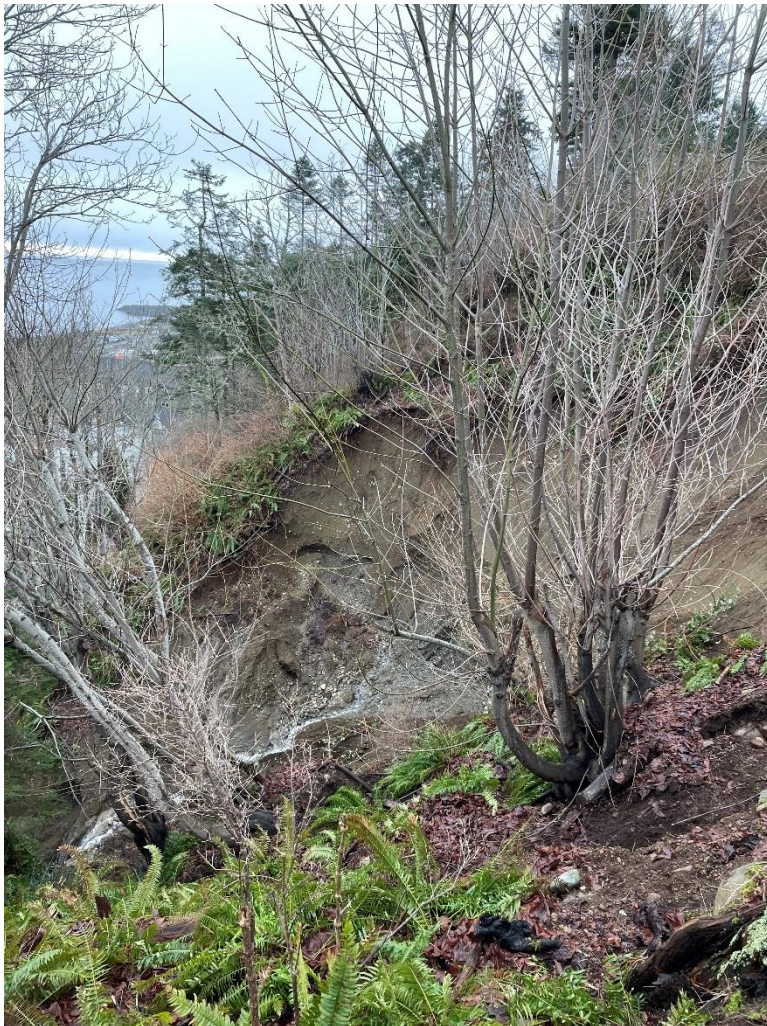
- In the southern exposed face of the landslide (Minor Scarp), a significant and concentrated amount of groundwater emerges from the face and flows down the slope in the same eroded trajectory as the landslide debris (see Photo 11). The source of the groundwater appears to be natural, as it is located at the interface of the permeable sands of the Quadra Sediments and the impermeable fine-grained soils underneath;

This initial assessment is specific to considerations of public safety. It is beyond the scope of this preliminary report to provide a detailed assessment or possible remedial measures. Our preliminary observations suggest that the concentrated spring like seepage likely caused saturation of the surficial colluvial type soil cover and a reduction in shear strength of the sandy deposits. It is also possible that the concentrated flow caused some erosion and local over-steepening of the slope. Given the nature of the failure (mudslide) the concentrated spring like discharge is considered to be central to triggering mechanism. Pre-landslide topography contours present evidence of historical erosion at that location.

Photo 11: Probable natural spring emanating from the southern face of the failure surface.

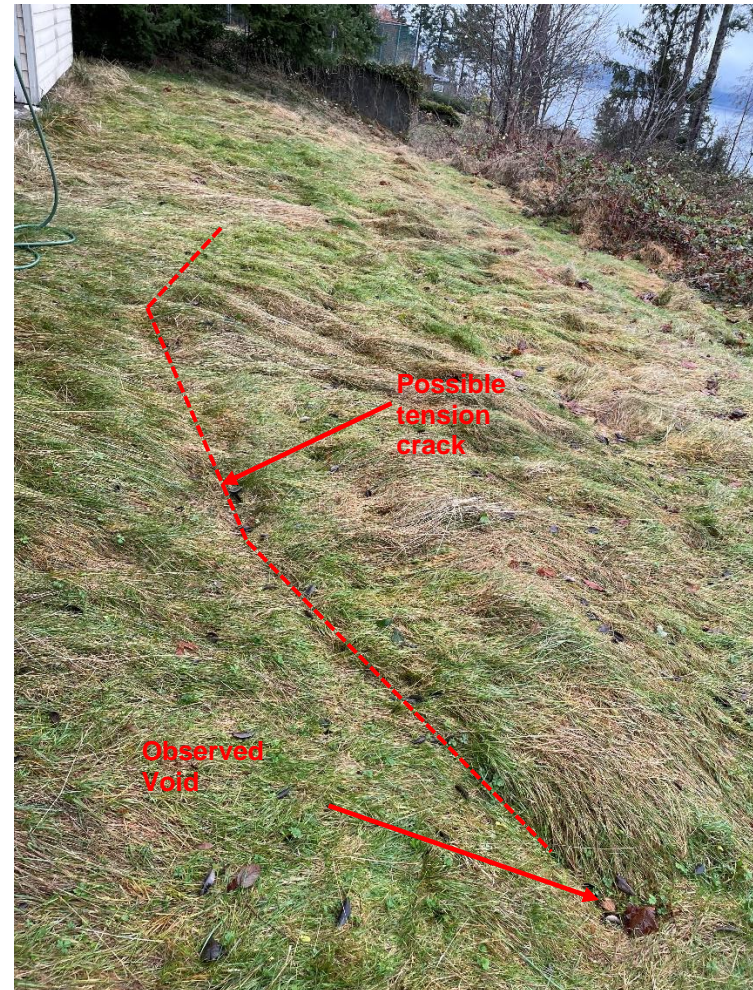
- The area at the top of the slope, at 739 Ash Street, has a thick and impenetrable cover of blackberry bush, which prevented access to the crown of the landslide. Between the blackberry bushes and the house structure, is a gentle eastward sloping grass covered backyard, about 5 m wide. As shown on Photo 12, the surface of this area appeared to be disturbed with indications of straining towards the crest. Probing with a steel rod encountered areas of very loose soil or possibly voids. The present owner mentioned they have been always present and not newly created by the landslide;

Photo 12: Grass covered backyard at 739 Ash Street. Possible tension crack visible in the grass area and void. City sewer line located between the visible crack and the crown of the landslide.

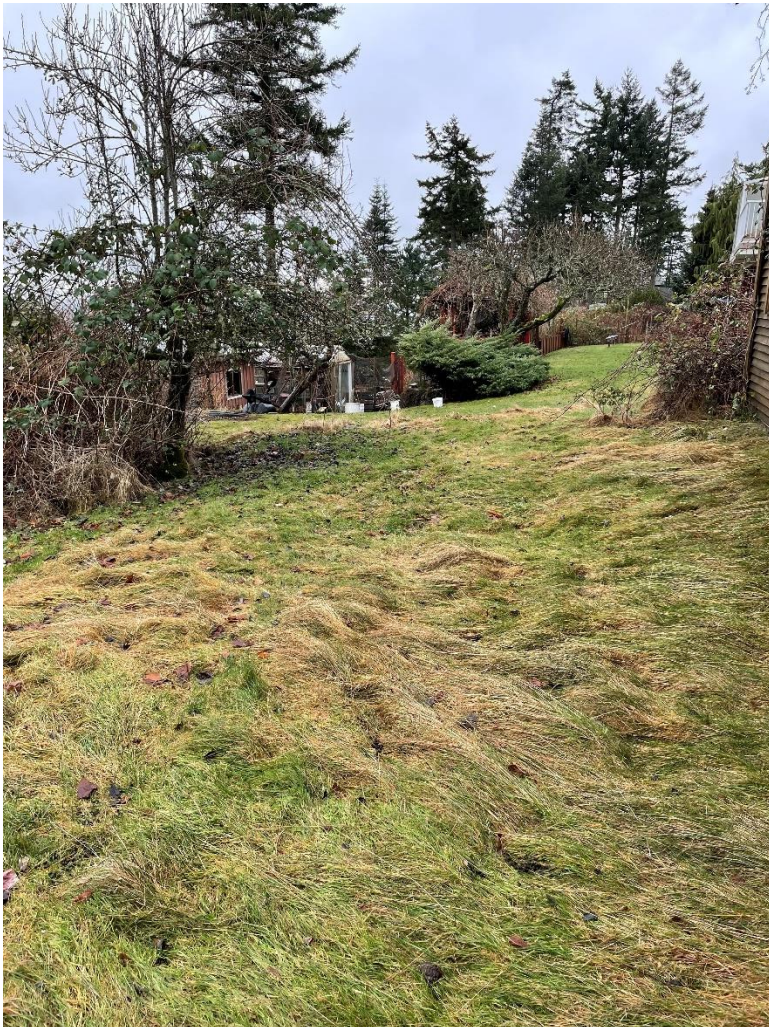
- The Eastern Wall of the house located at 739 Ash Street is located approximately 15 m from the Crown of the landslide;
- A garage or shed at 751 Ash Street is located dangerously close to the southern side of the landslide;

Photo 13: Grass covered backyard at 739 Ash Street and shed/garage located at 751 Ash Street in the background.
