# OSTLER PARK FORESHORE RESTORATION PROJECT CONCEPTUAL DESIGN REPORT

RFP 16-12 | September 6, 2016 | Submitted by: Mark DeGagné, P.Eng.

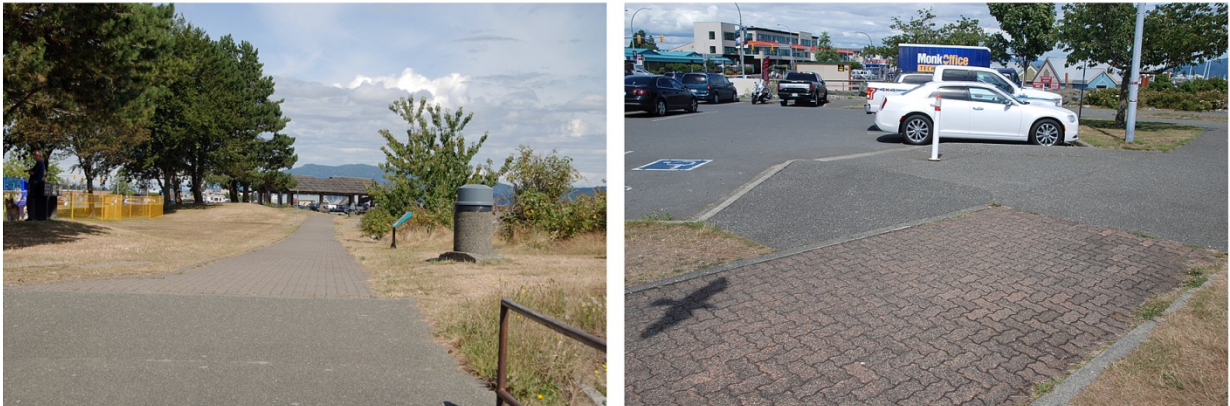
*Figure 5.2 - Connections with adjacent walkways*  
Sea Gull Walk (left) and at parking lot to north (right). Note abrupt grading transition at end of Sea Gull walk and difference in width. Sea Gull walk is elevated over an armoured shoreline and is therefore 'fixed'. Both walkways are exposed aggregate cast-in-place concrete. Current DFO policy does not support exposed aggregate finishing at the shoreline due to deleterious effects of washing off the surface retardant chemicals to fish habitat.

At either end of the walkway the connecting paths vary in width, materials and finishes (**Figure 5.2**) below.

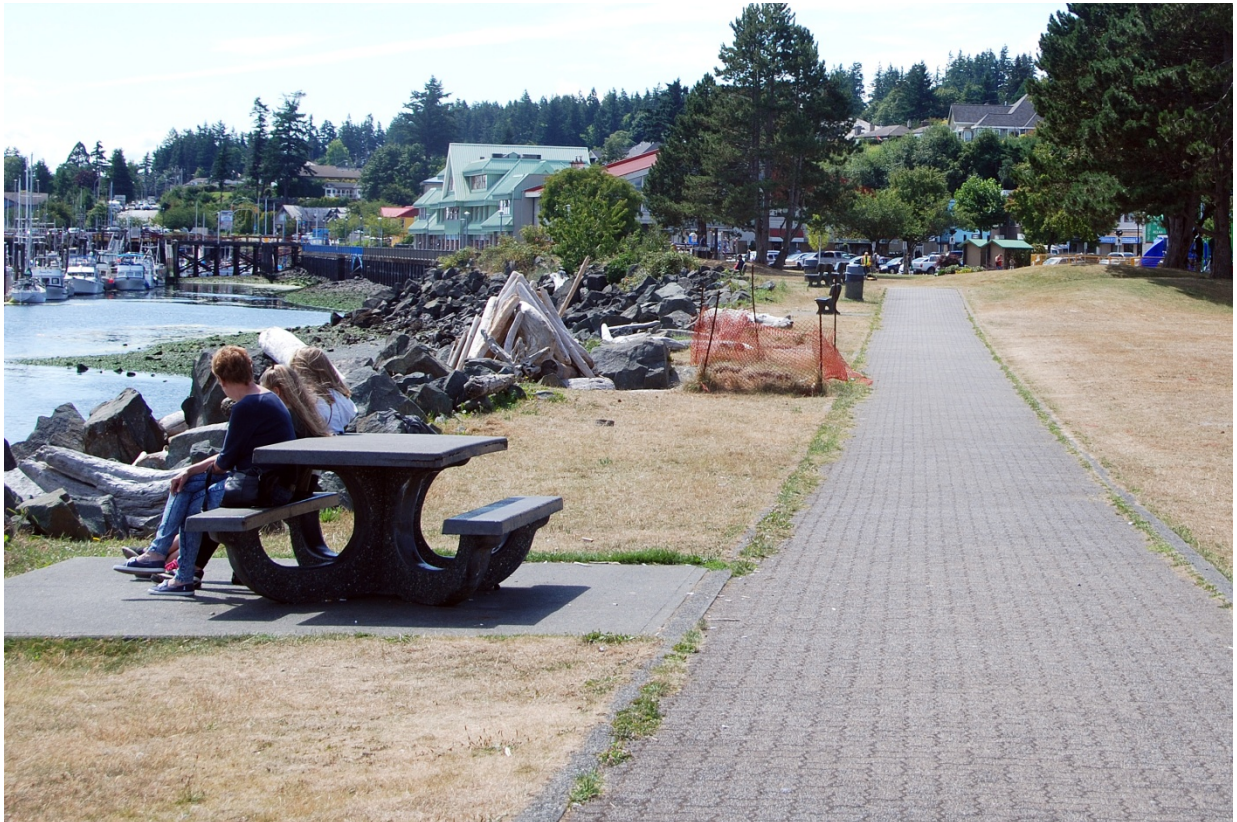
*Figure 5.3 - Site furnishings require oversize concrete pads*  
These features effectively require 3-4m of level land at the back of the beach. In the current armoured-bank situation, some of the slabs (and benches) have been damaged by over-topping waves (red snow fence - mid-ground). A few of the benches have been damaged by hurled logs during storms. Some of the site furnishings do not have pads extending fully back to the walkway limiting accessibility of the mobility-challenged.

The CCR Parks department used regionally-made concrete benches and picnic tables as standard furnishings along its Sea Walk however the current policy is to use furnishings manufactured of recycled materials, such as at Dick Murphy Park. The existing memorial benches and tables will require replacement. Many of these are 'memorial' pieces with dedication plaques, often benches were purchased with place-specific locations in mind (e.g. views). There are currently 5 benches and 1 picnic table, mounted on cast-in-place slabs, arrayed along the seaward edge of the existing walkway alignment (**Figure 5.3**, below).

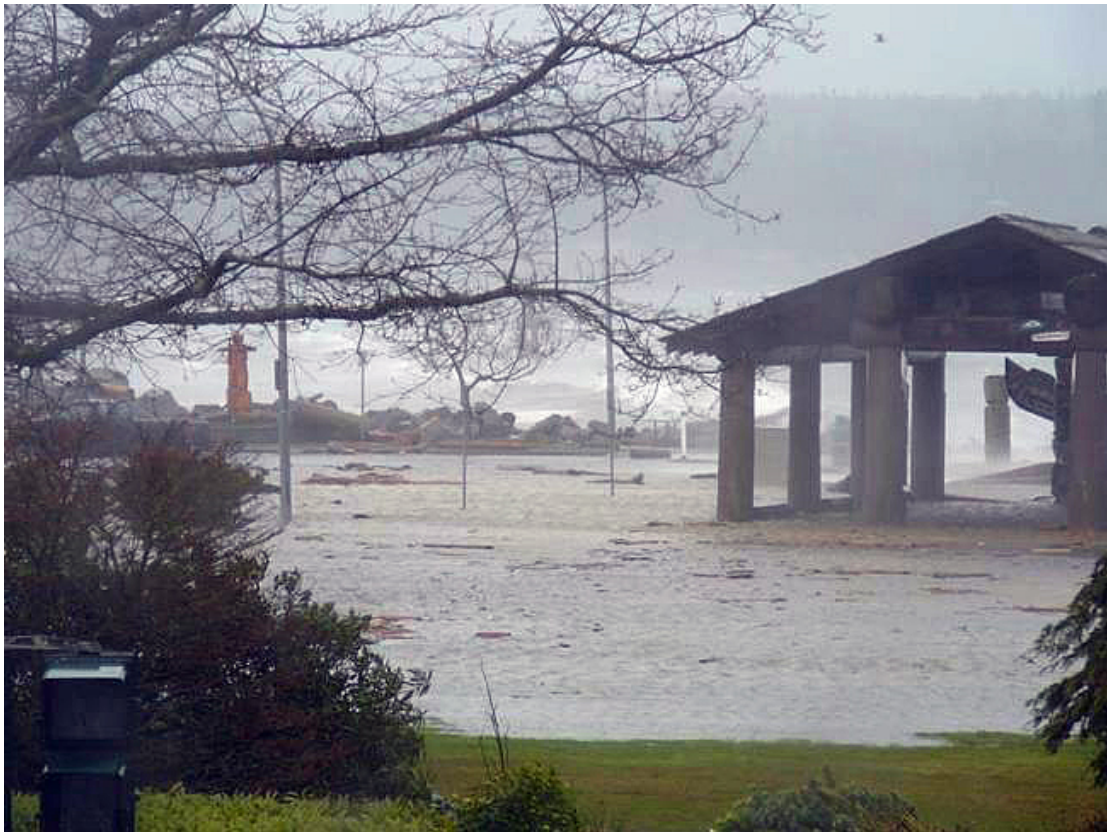
*Figure 5.4: Flooding at the Kwiakah Longhouse  
Note the extent of pooling over lawn in middle ground.*

Under existing conditions, it is prone to flooding and damage from debris being tossed over the walkway during large storms (**Figure 5.4**, right Image credit: [www.campbellriver.ca](http://www.campbellriver.ca)).

**Lawn:** As shown previously on **Figure 5.4** the central lawn area to the west of the longhouse is both, prone to salt water inundation, and has poor surface drainage. The area is low, without a path for surface drainage to flow out and lacks drainage infrastructure such as catch basins or subsurface drain structures. Consequently, the lawn is in poor condition and the area tends to be 'boggy' during the winter and shoulder seasons.

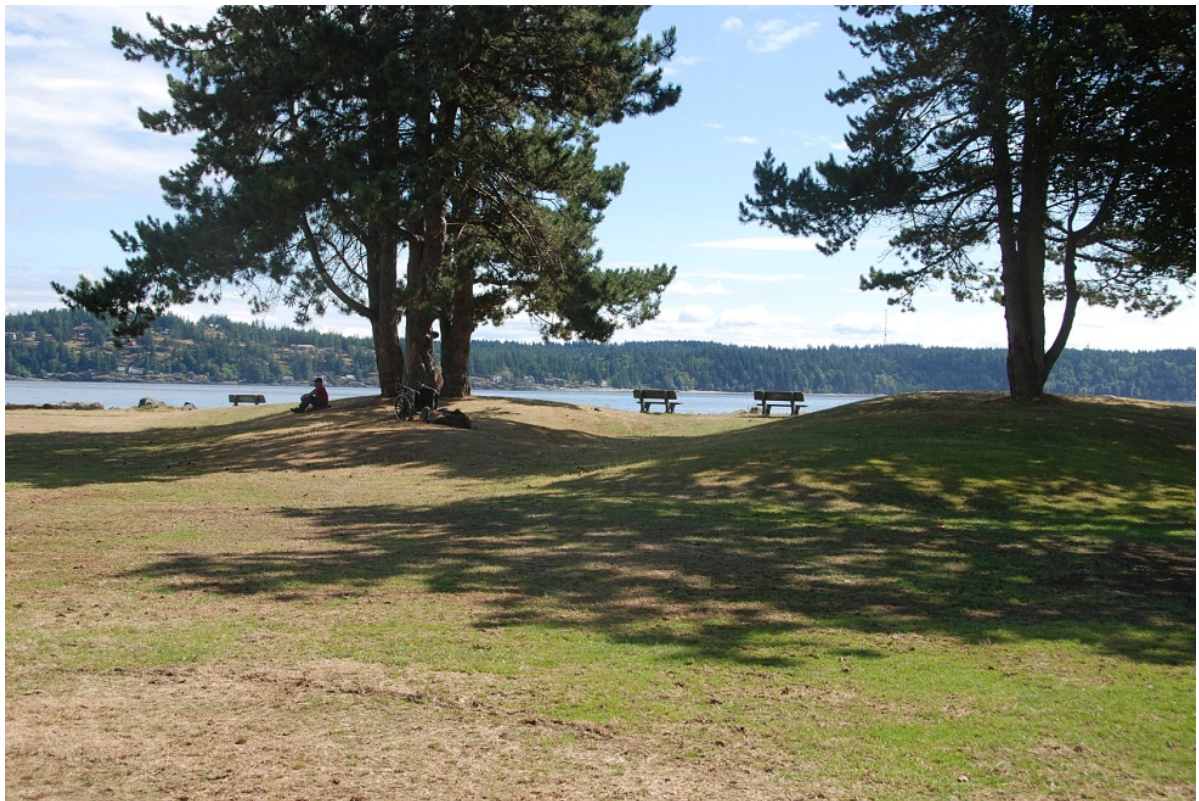
*Figure 5.5: Mid-Park Landforms with Mature Trees*

**Existing Treed berms:** Approximately midway along the existing walkway alignment there is a pair of low landforms with mature Austrian pines at/near the top (4.15-4.85m elevation) as shown on **Figure 5.5**.

Some of the trees will be *directly* affected by the proposed walkway alignment. Unfortunately, trees grown in groups tend to reveal large bald areas on those individuals left after removal of their neighbours. Trees closer to the new playground should be unaffected.

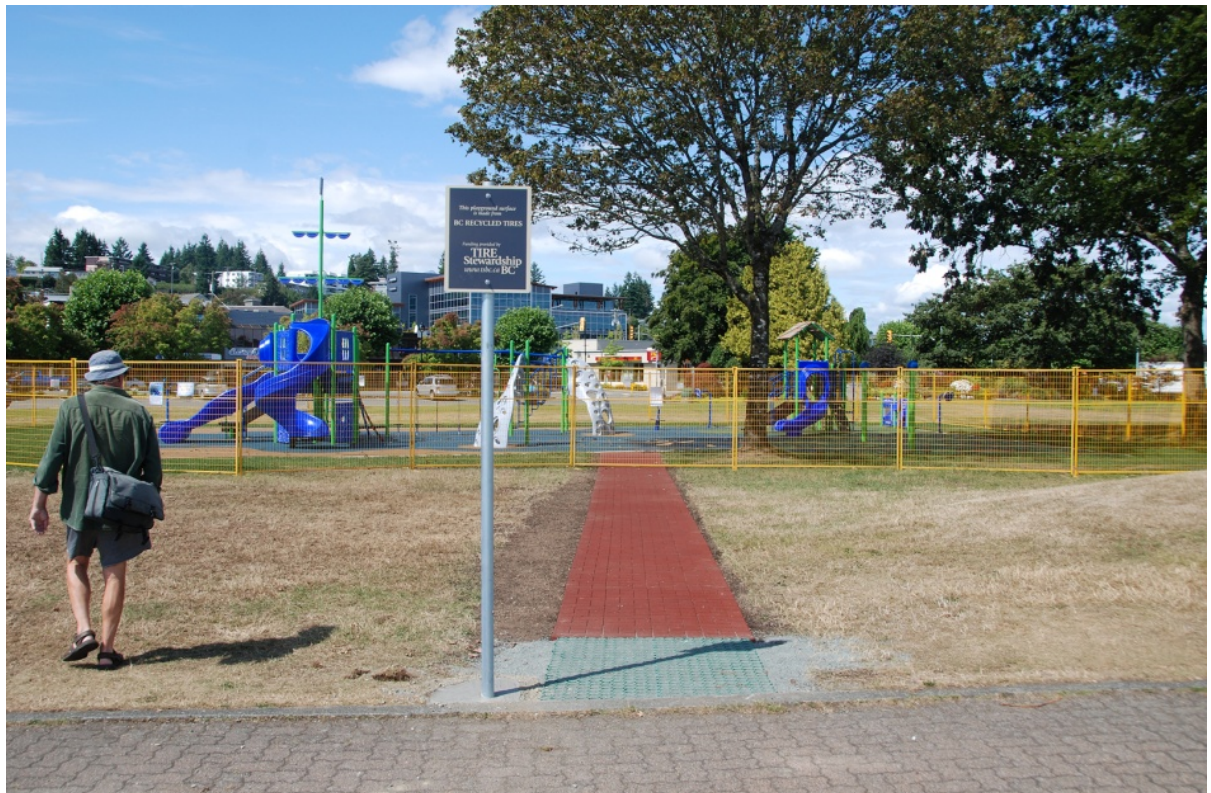
*Figure 5.6: New Play Area constructed June-July 2016*

- Deciduous trees on the east and northeast sides will continue to provide shade.
- The newly-constructed access pathway from the play area to the existing shoreline walkway (**Figure 5.6**) will need some vertical and horizontal alignment adjustments to meet the proposed shoreline promenade re-alignment.

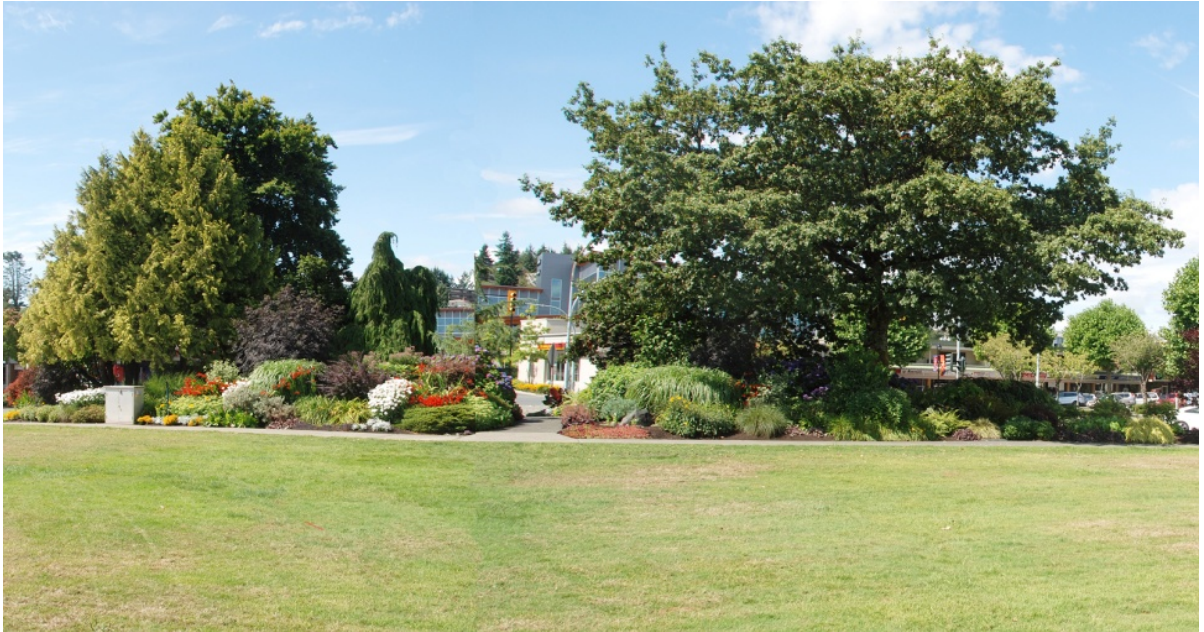
*Figure 5.7: Garden Areas at St. Ann's and Highway 19A*

A horticulturally-rich and extensive planting bed provides an aesthetic pedestrian entry point from the intersection - into the park. This bed contains some significant specimen trees and mature ornamental plants (**Figure 5.7**).

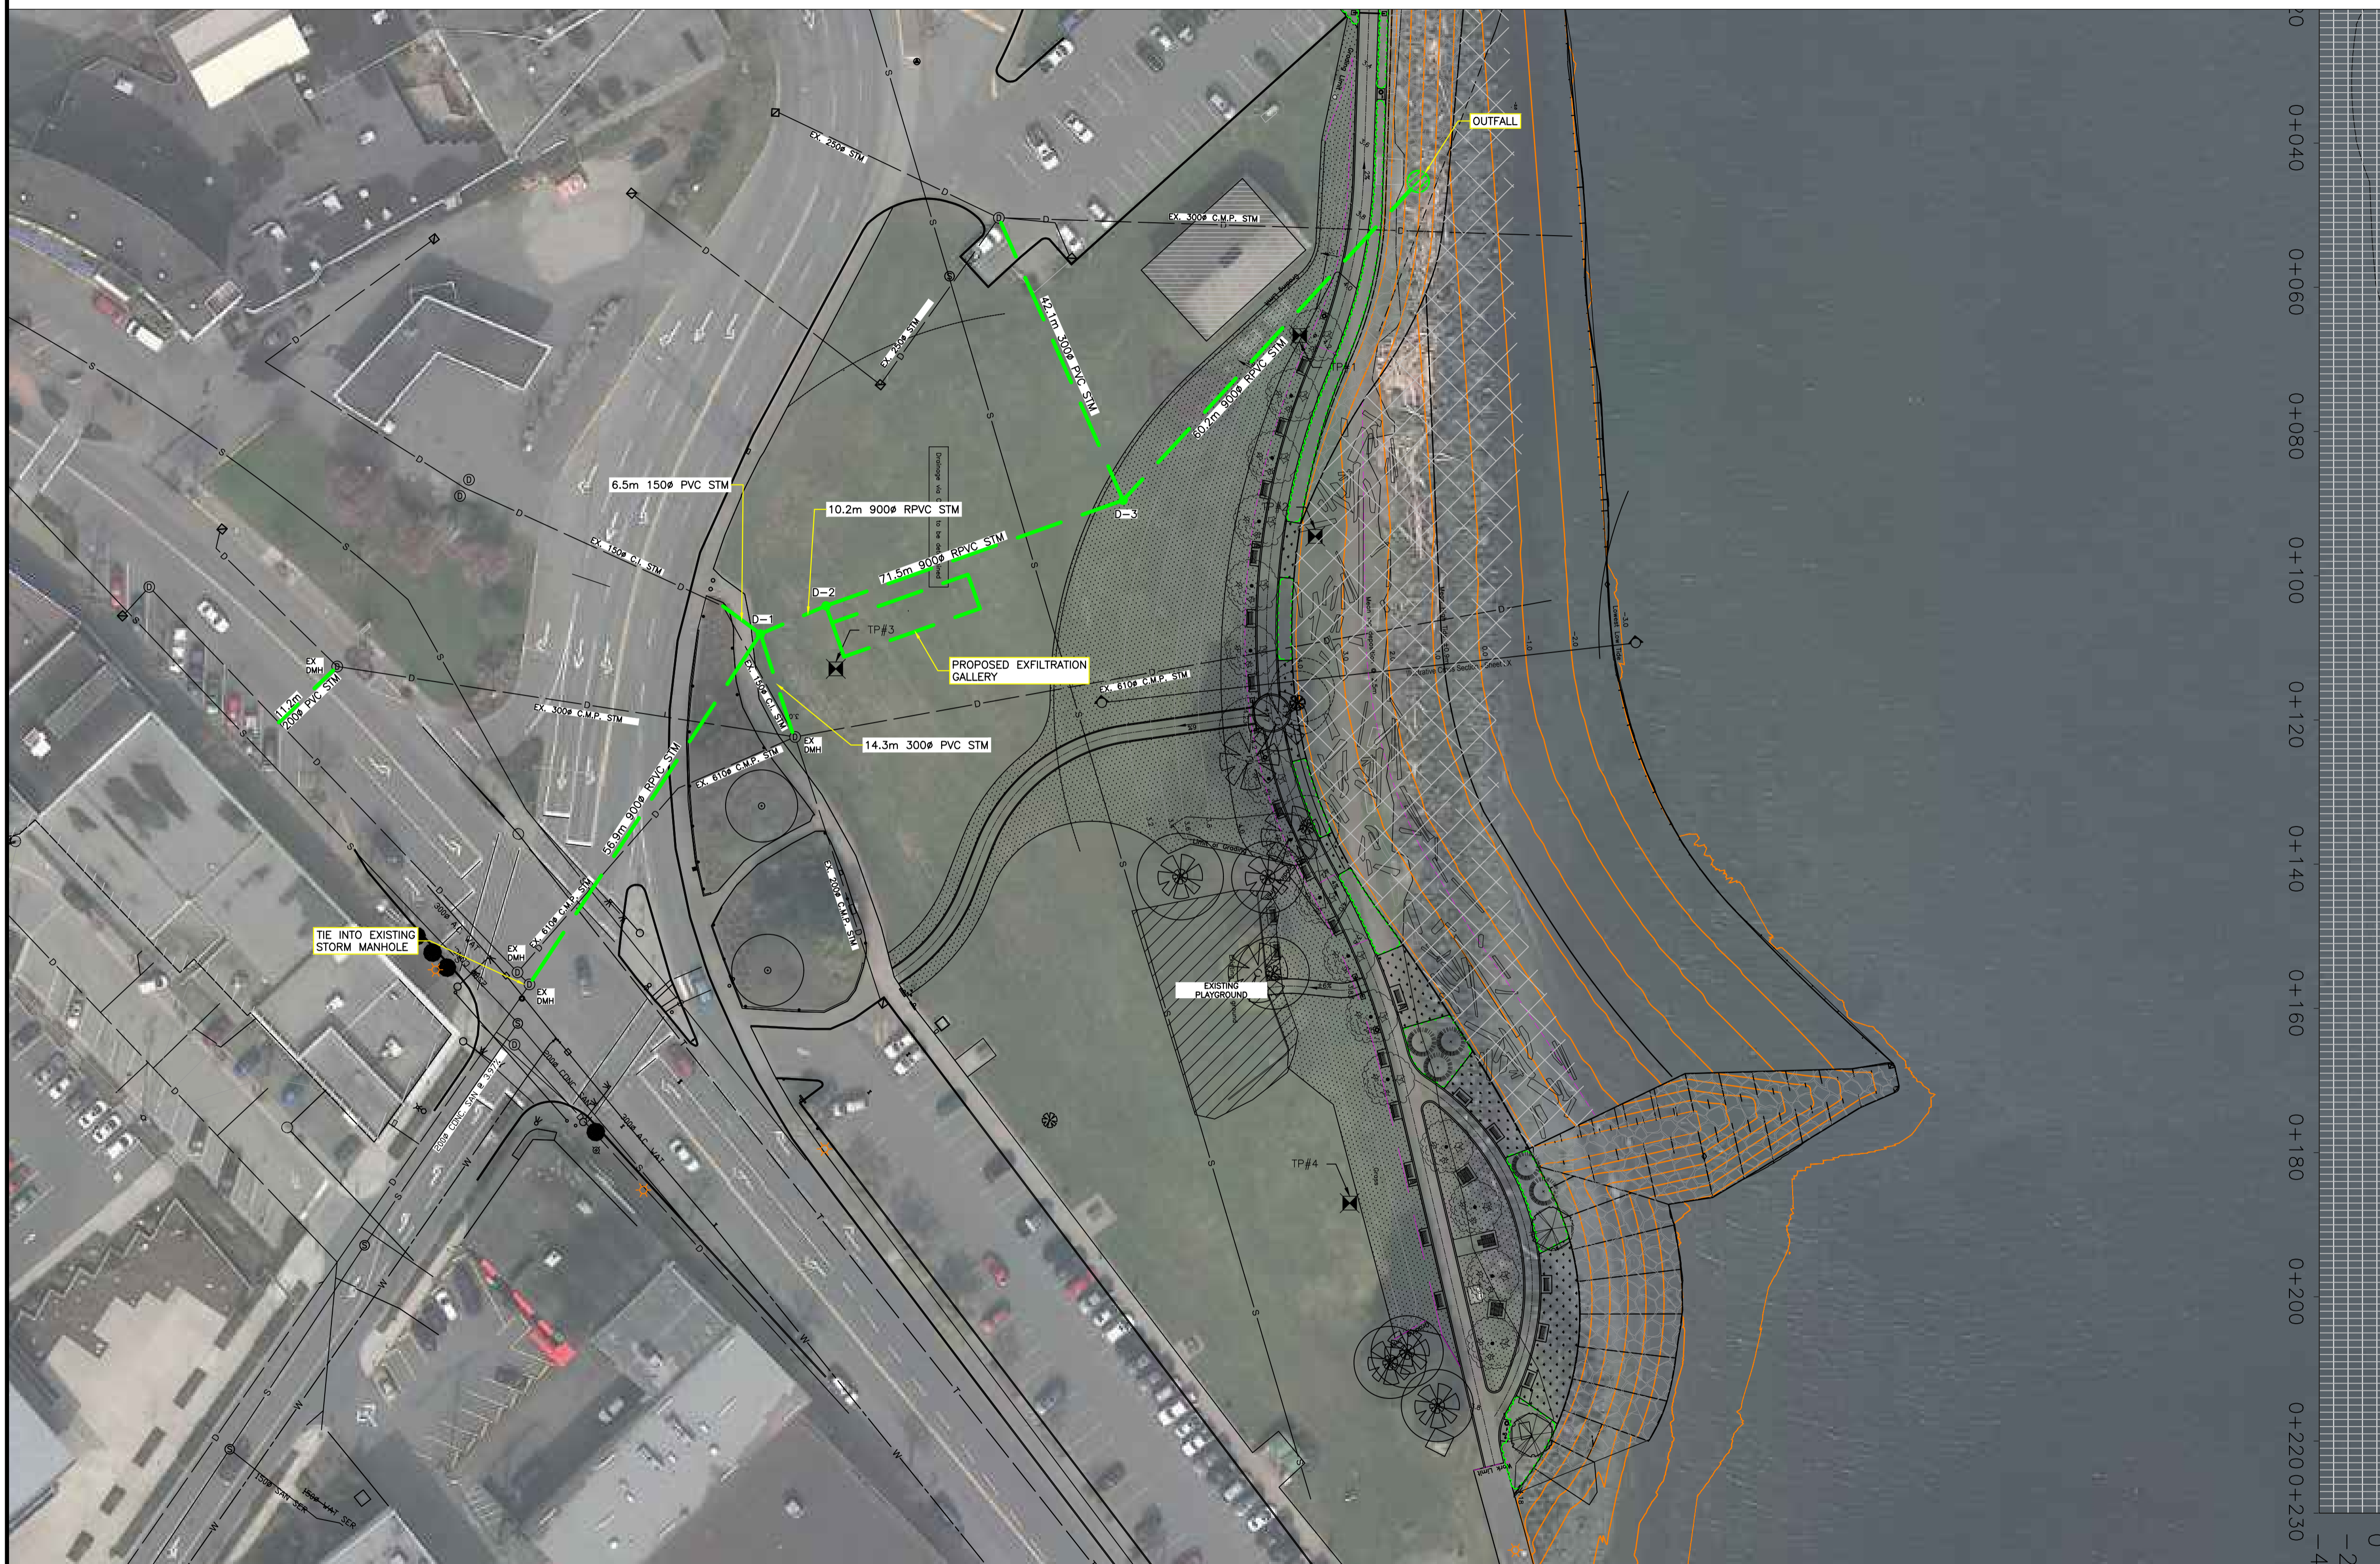
FIG. 4.4  
PROJECT:  
2221-49015-0

CITY OF CAMPBELL RIVER  
OSTLER PARK FORESHORE RESTORATION  
STORM DRAIN UPGRADE - OPTION 2  
CAMPBELL RIVER, B.C.

Two possible storm system alignments are provided on the attached **Figure 4.3 and 4.4**. The first (option 1) shows an alignment below the walkway that bisects the gardens at the southeast corner of the St. Ann's-Highway intersection. This alignment would require curving a part of the sewer, which is well within manufacturer's recommendations. It also requires an additional manhole, which is a significant cost because of the size of the pipe.
